Simulation of 12 High Geosynthetic Reinforced Retaining Walls Under Surcharge Loading by Centrifuge Testing

James M. Klamerus
Hon-Yim Ko
University of Colorado
Department of Civil, Environmental
and Architectural Engineering
Boulder, Colorado 80309

Final Report
April, 1998

CDOT-DTD-R-98-6

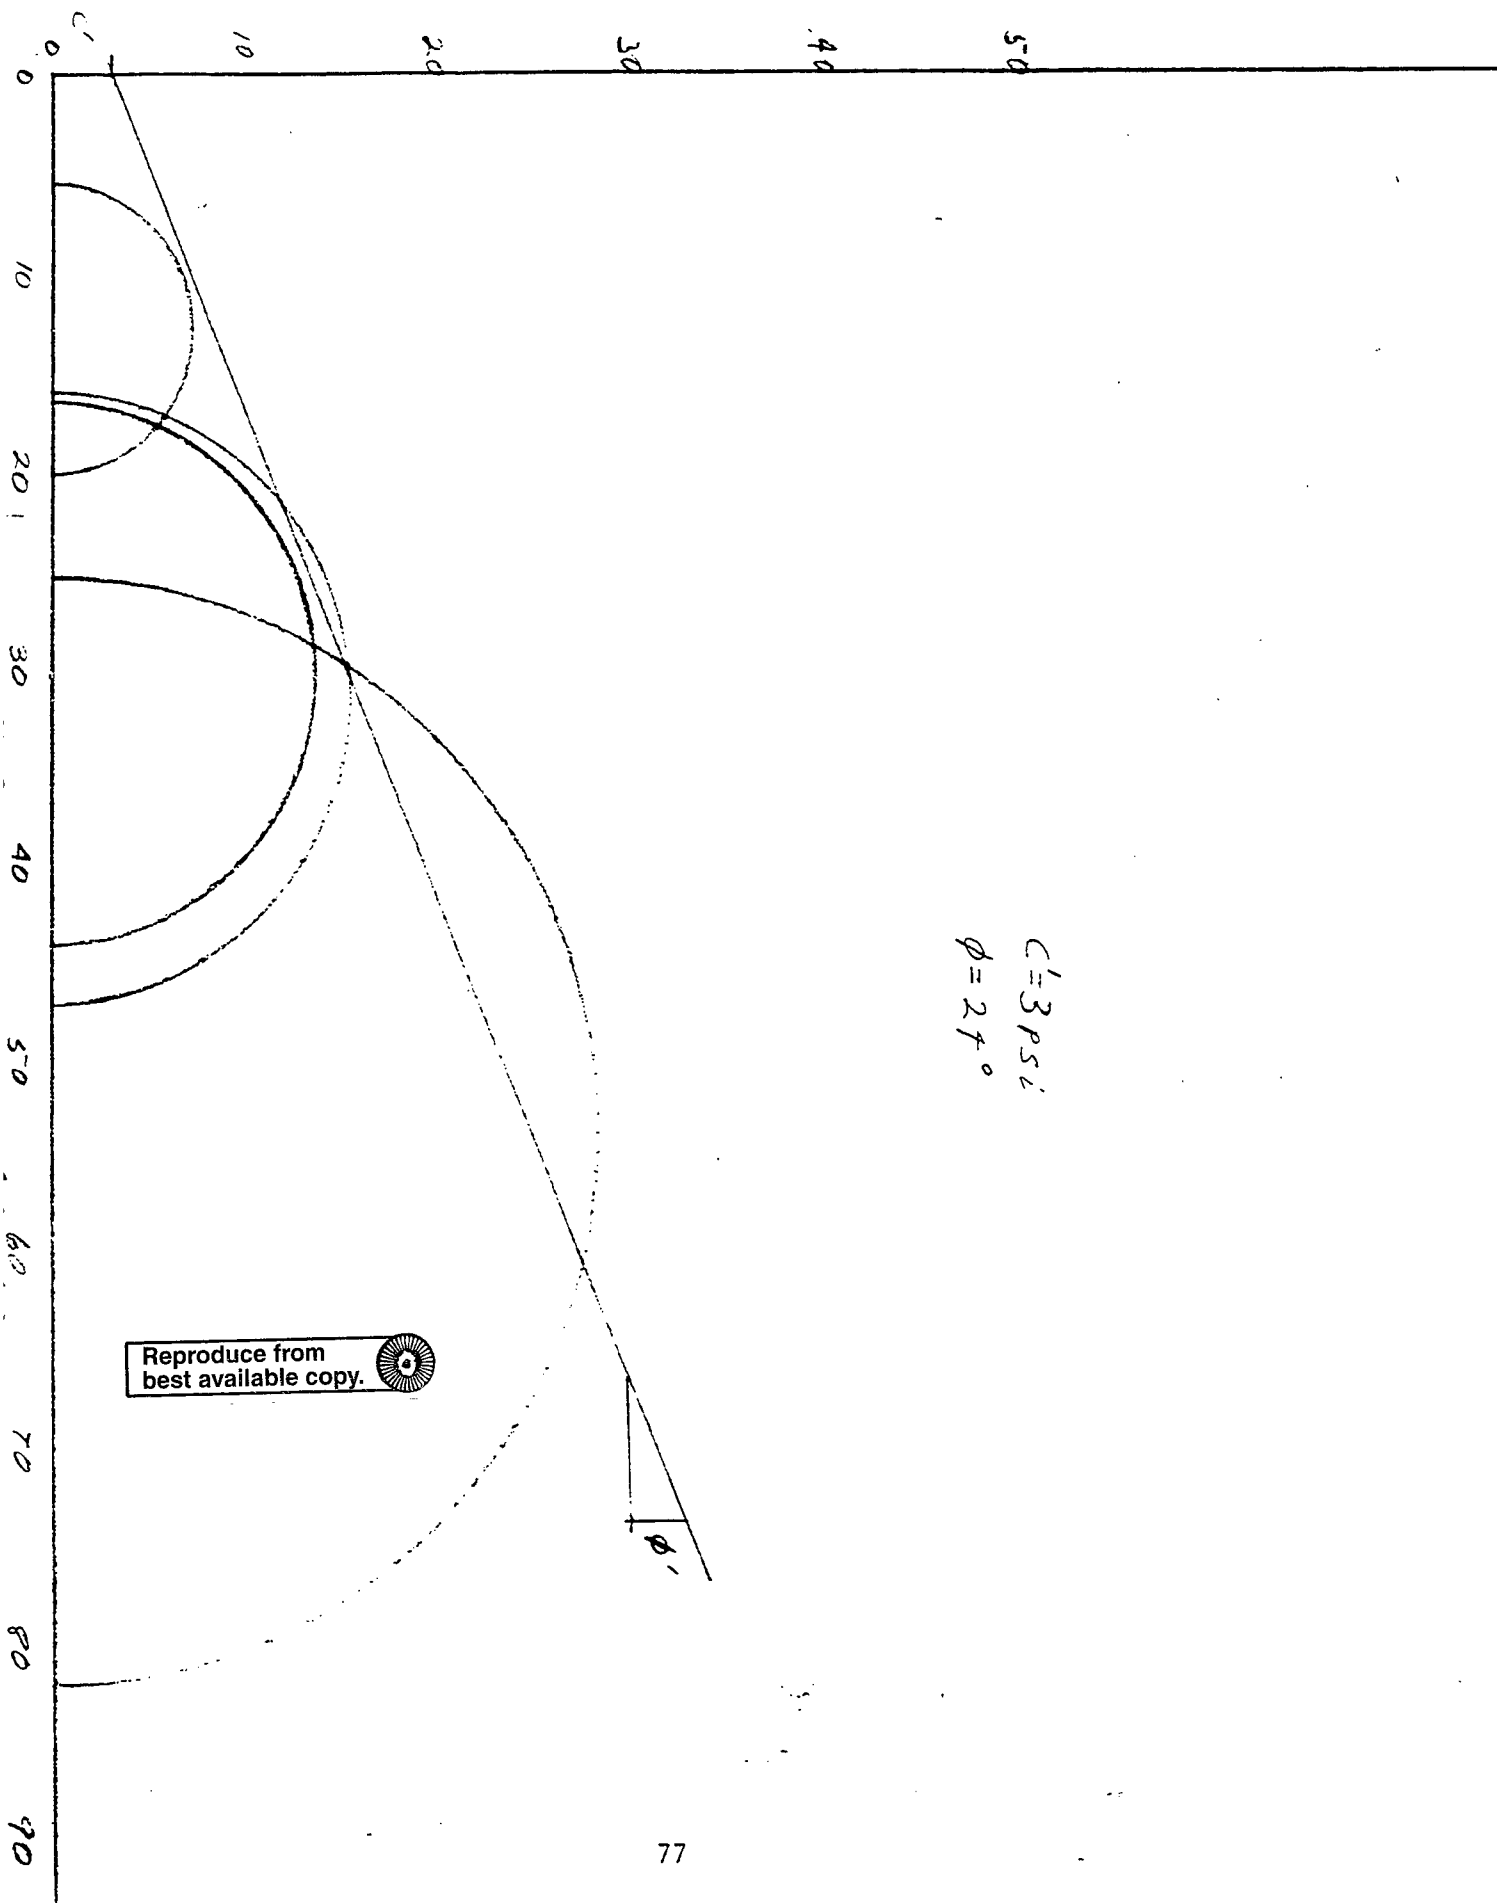
The samples should have been given a much greater time to become saturated as can be seen by the low B parameter values. Failure was chosen at the stress where the pore pressures started to decrease. It would be nice to run a set of odometer test in order to complete the Cam Clay model. The values of Cohesion and angle of internal friction of 3 Psi. and 24 degrees seems reasonable for this type of material.

Shear Stress, τ , (PSI)
